# Manhole Inspection Summary

Manhole # S25KK\_013MH

Insp Date: **8/28/07 12:22 PM**

**Location** Address: **342 BLOOM ST**

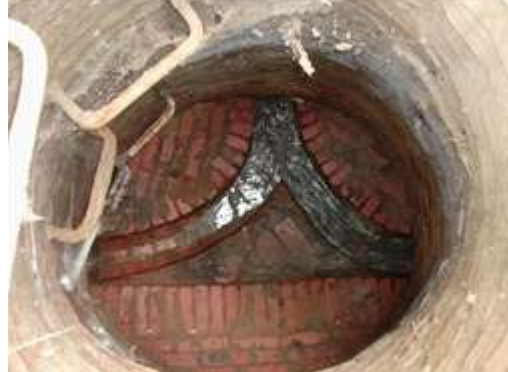
Top View

Corroded steps. Evidence of surcharge - Bench debris.

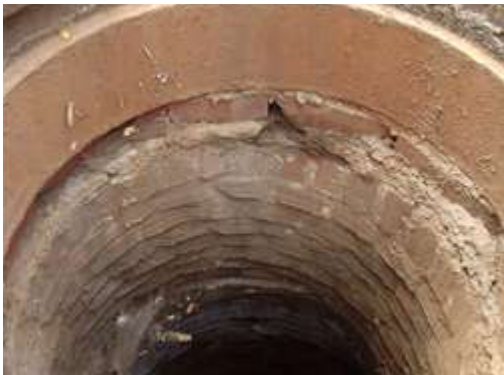
Defect

Frame leaks. Adjustment deterioration, loose brick and infiltration. Corbel and Barrel infiltration - other side.

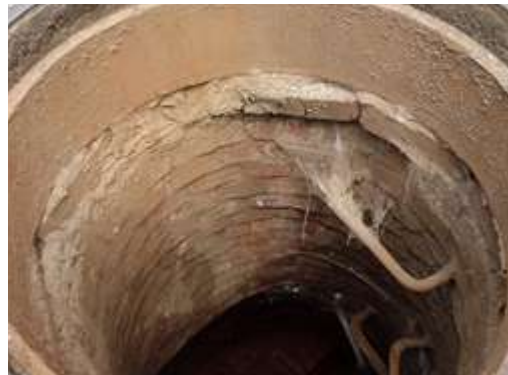
Defect

Frame leaks. Adjustment deterioration, loose brick and infiltration. Corbel and Barrel infiltration.

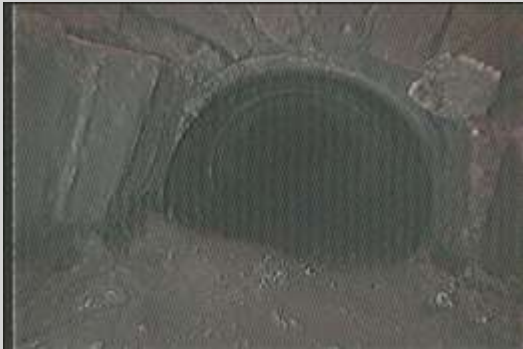
### 8 in. Circular Gravity Sewer Pipe Out @ 12 O'Clock

Infiltration: **Evidence** Pipe Seal Cond: **Cracked**

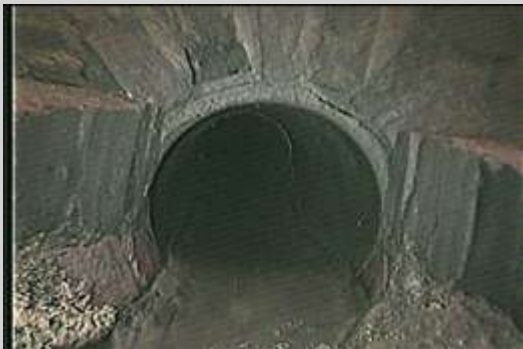
### 8 in. Circular Gravity Sewer Pipe In @ 3 O'Clock

Infiltration: **None** Pipe Seal Cond: **Unknown**

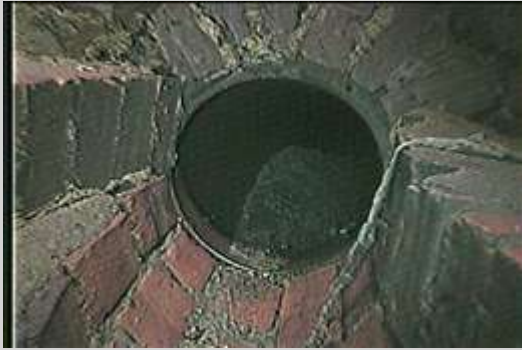
Pipe In @ 9 O'Clock

Deposits: ☐ None ☒ **Mud** ☐ Sludge ☒ **Debris** ☐ Grease

Silt Depth: **1** (in.)

Deposits Extent: **Light**

Infiltration: **Evidence**
